Steep Cut Slope Composting: Field Trials and Evaluation

Plot Construction Report

Montana Department of Transportation
P.O. Box 201001
Helena, MT 59620-1001

February 12, 2009

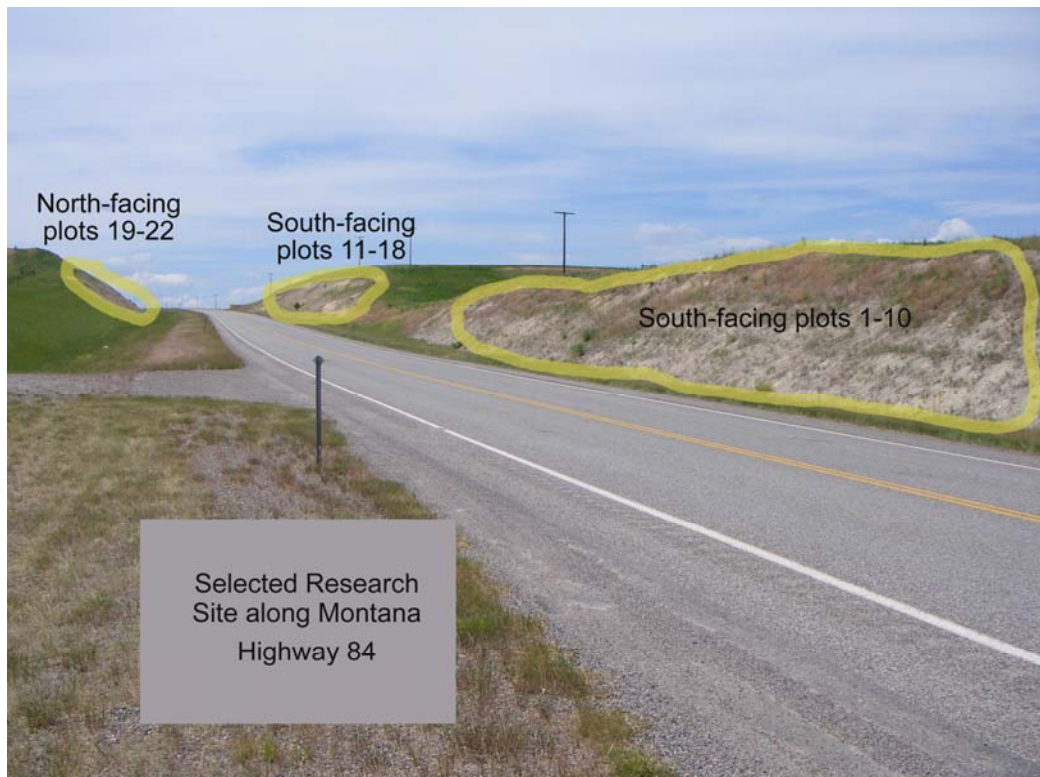
Figure 1: Roadside overview of research site location along Montana Highway 84

A test site was located approximately 25 km (15 mi) west of Bozeman on MT Highway 84 (Figure 1). This road reconstruction project was completed in 2002. Steep slopes were cut into tertiary-age sedimentary parent material. Slopes did not receive a topsoil application before seeding during post-construction reclamation. In 2008 these slopes were nearly devoid of vegetation; approximate canopy cover ranged between 1 – 5 percent across the test plots.

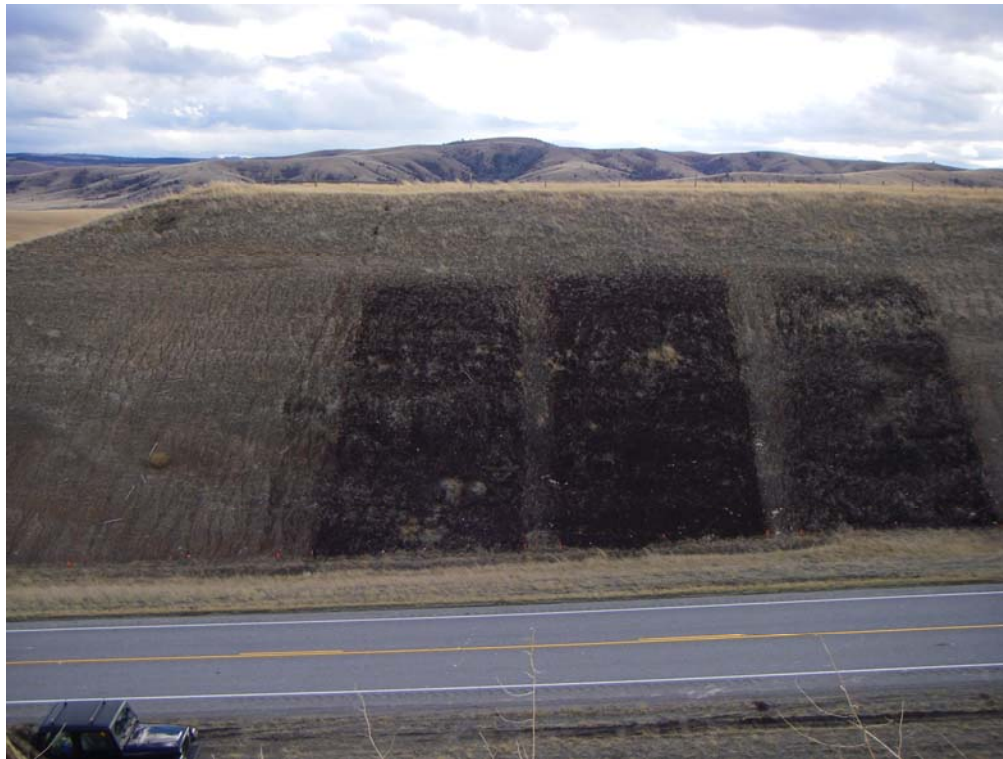
Figure 3: View of four north-facing plots that are directly across the highway from the eight south-facing plots. The furthest plot to the east (left) as shown in the image is a control plot without compost application. Close inspection of the photo shows orange stakes and paint marking the outline of plot 19 (untreated control).

Based on the experimental design for this research project (Table 1), 22 plots were laid out at the research site. Plot construction occurred on 11-14 November 2008. Four plots were located on the north-facing slope (Figure 3) and 18 were located on two separate south-facing slopes. Eight of the south-facing plots were placed across the highway from the four north-facing plots (Figure

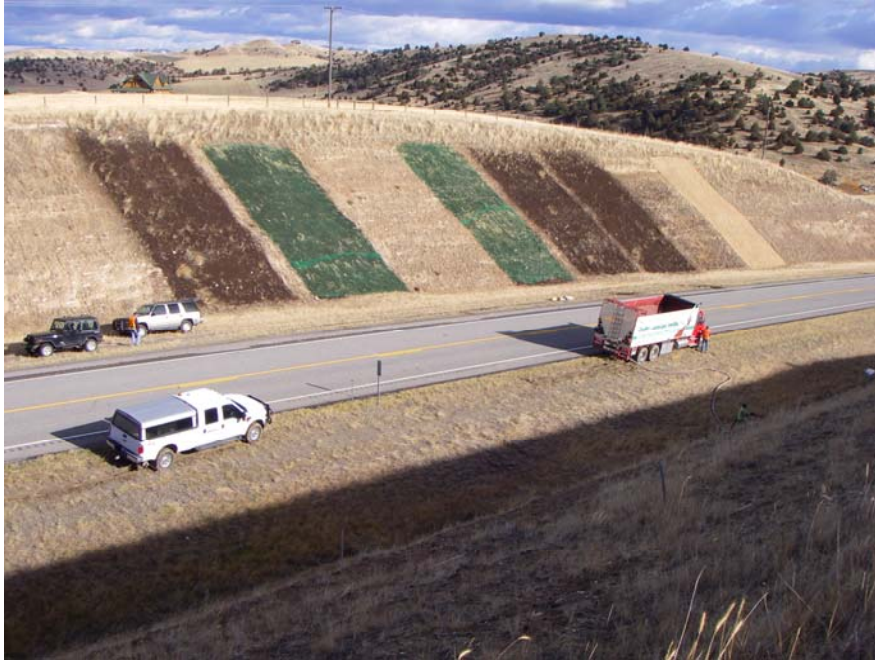
Figure 4: View of eight south-facing plots that are across highway from the four north-facing plots. Plot 11 is shown furthest to the left in the image (dark colored) while plot 18 is most distant (to the right or east) covered by a tan colored erosion control blanket.

4) and the 10 other south-facing plots are located together approximately 200 m to the east (on the right in Figure 5).

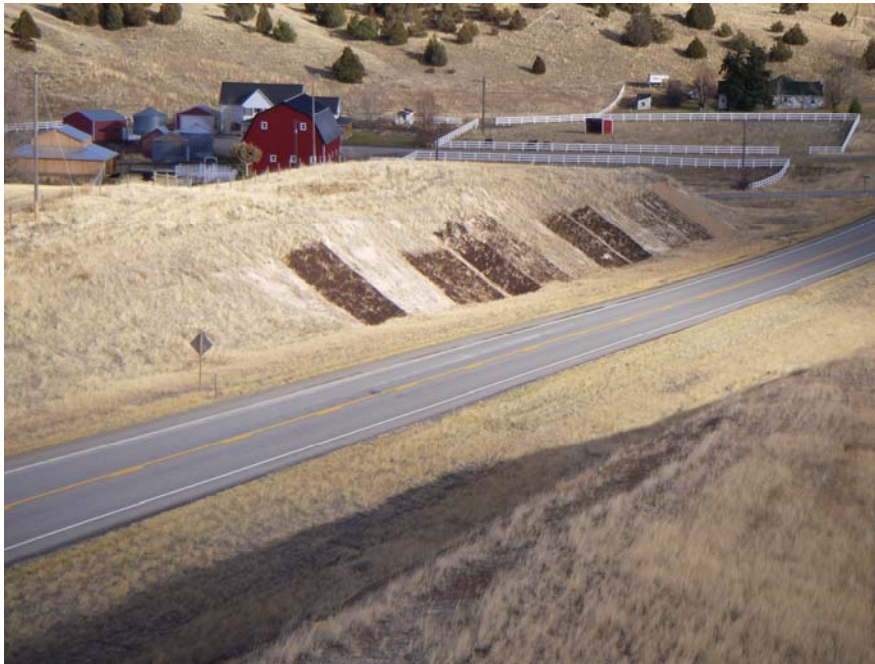
Figure 5: View of ten south-facing plots that are on the east end of the research site. Plot 1 is furthest to the left in the image (dark colored) and plot 10 is most distant (to the right or east) with a tan colored erosion control blanket.

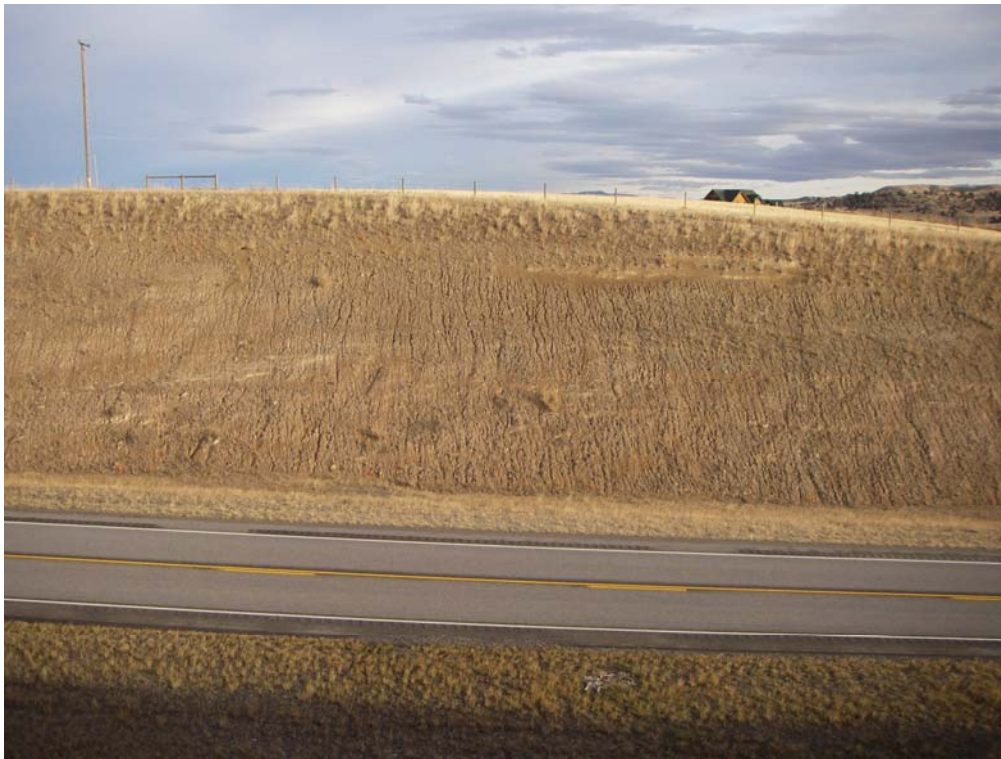
Figure 6: Evidence of sparse vegetation on slopes before test plot construction.

This lane widening road project was completed in 2002. By the autumn of 2008 these slopes remained nearly devoid of vegetation. Some sparse vegetation was evident on the test site (Figure 6). The MDT Reclamation Specialist conducted an ocular sampling to characterize the vegetation on the site on 4 November 2008. At this time of year, all vegetation was senescent at the time of seed bed preparation. Vegetation cover was less than 5 percent and comprised principally of weedy species and remnants of the seed mix used after construction of the road widening project in 2002. The dominant desirable species observed was slender wheatgrass, *Elymus trachycaulus*. These plants were widely spaced and comprised less than 1 percent cover. The dominant invasive species observed was cheatgrass, *Bromus tectorum*, and several spotted knapweed, *Centaurea maculosa*, plants. Trace amounts of other species were observed. Plant cover present was insufficient to control erosion and provide soil stabilization.

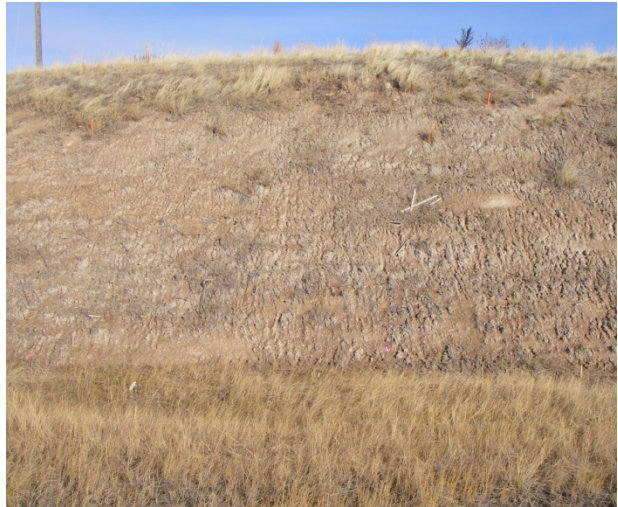
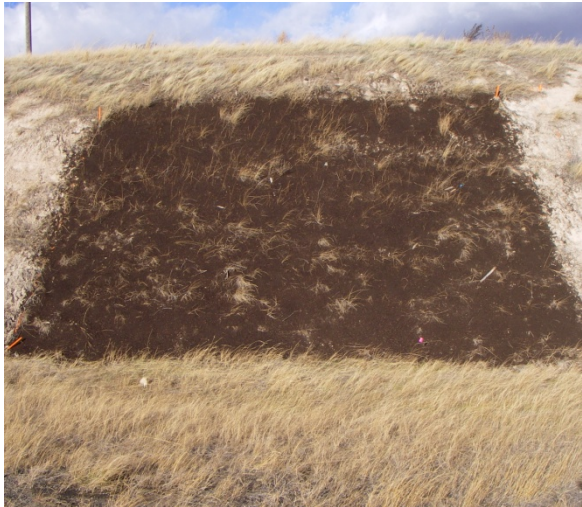
A photograph of a steep, eroded cut slope covered in dry, yellowish-brown grass and soil. The slope shows signs of weathering and erosion, with a rough, textured surface. The foreground is a flat area of similar dry grass.

A photograph of the same cut slope as in the 'Before' image, but now covered with a thick, dark brown layer of compost or organic material. The slope appears more stable and the surface is smoother. The foreground remains the same dry grass.
Plot 1 Before Construction	Plot 1 After Construction

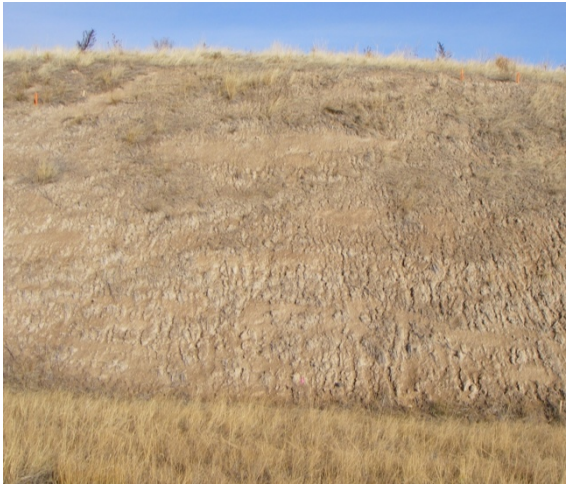
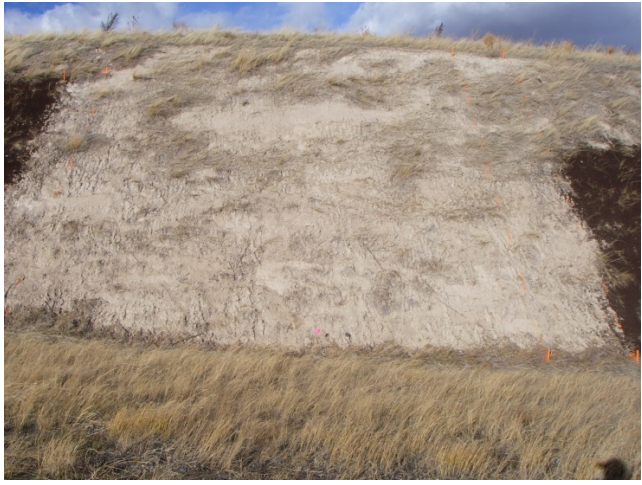
Plot 2 Before Construction	Plot 2 After Construction

A photograph of a steep, eroded cut slope covered in dry, yellowish-brown grass and soil. The slope shows signs of weathering and erosion, with a rough, textured surface. The foreground is a flat area of similar dry grass.

A photograph of the same cut slope as in the 'Before' image, but now covered with a thick, light-colored layer of compost or organic material. The slope appears more stable and the surface is smoother. The foreground remains the same dry grass.

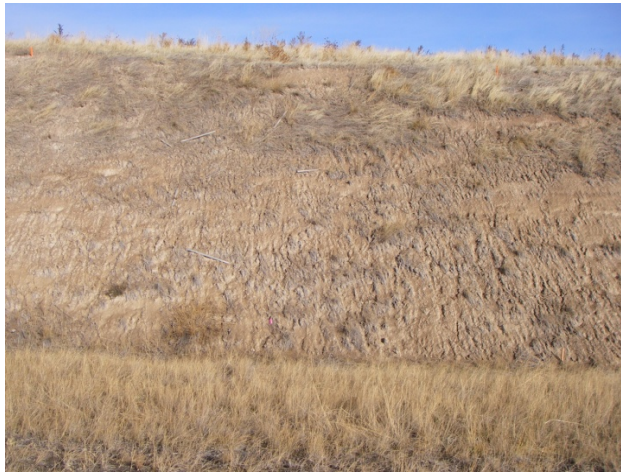
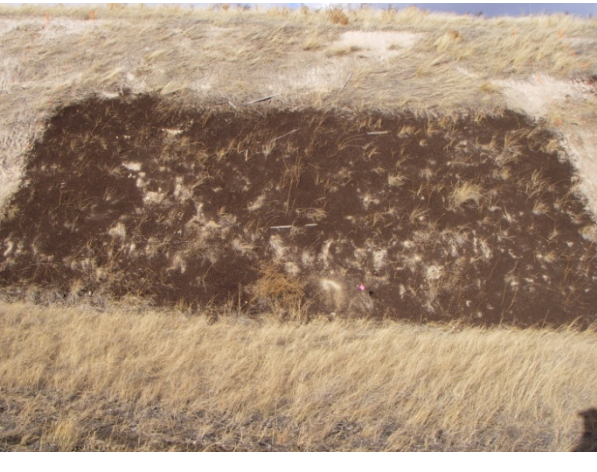
A photograph of a steep, eroded cut slope covered in dry, yellowish-brown grass and soil. The slope shows signs of weathering and erosion, with a clear horizontal line of vegetation at the base.

A photograph of the same cut slope after construction. A large, dark, rectangular area of composted material has been applied to the upper portion of the slope, contrasting sharply with the surrounding dry grass and soil.
Plot 3 Before Construction	Plot 3 After Construction

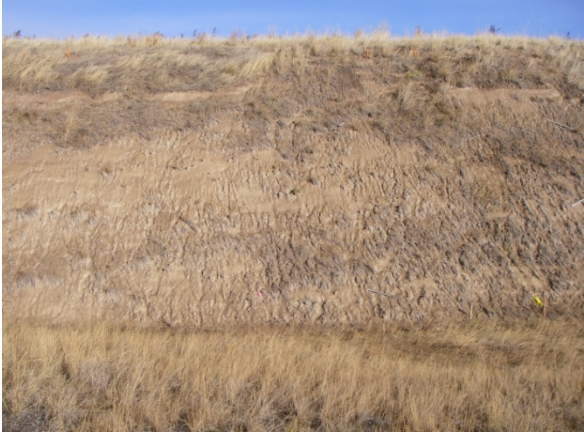
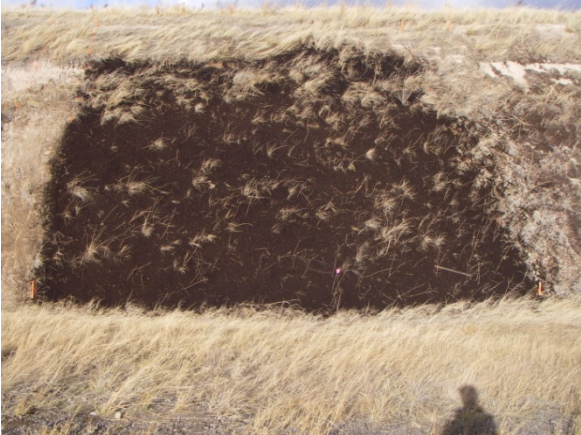
Plot 4 Before Construction	Plot 4 After Construction

A photograph of a steep, eroded cut slope covered in dry, yellowish-brown grass and soil. The slope shows signs of weathering and erosion, with a clear horizontal line of vegetation at the base.

A photograph of the same cut slope after construction. A large, dark, rectangular area of composted material has been applied to the upper portion of the slope, contrasting sharply with the surrounding dry grass and soil.

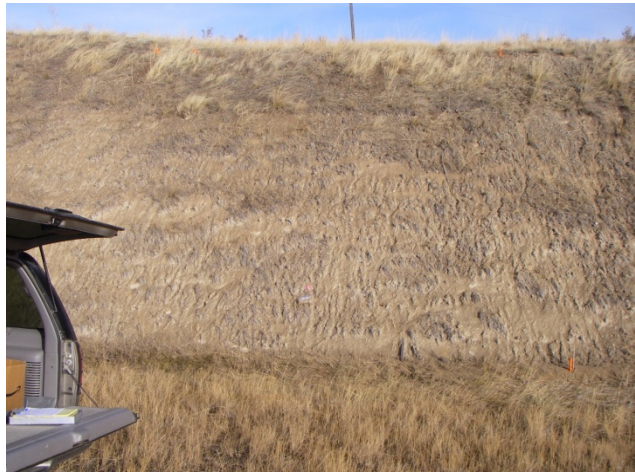
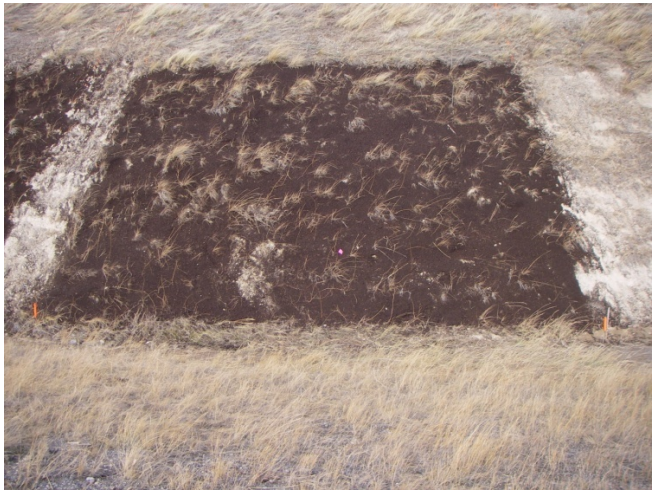
A photograph of a steep, eroded cut slope covered in dry, yellowish-brown grass. The soil surface is exposed and shows signs of erosion. The rear of a vehicle is visible on the left side of the frame.

A photograph showing the same cut slope as in the 'Before' image, but with a large, dark, rectangular area of compost applied to the face of the slope. The compost is dark brown/black and appears to be held in place by some vegetation or mesh.
Plot 7 Before Construction	Plot 7 After Construction

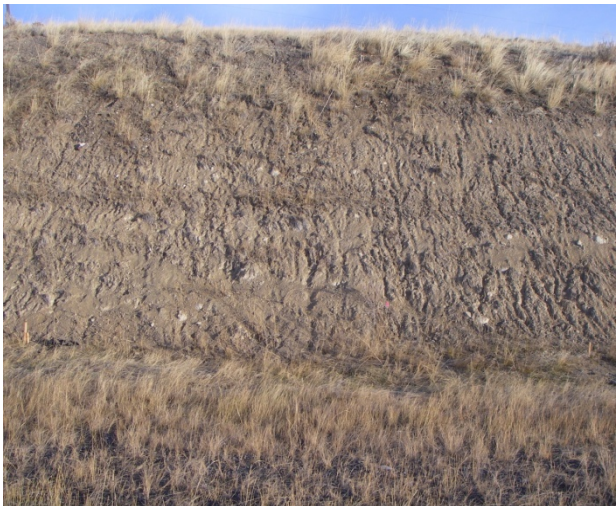
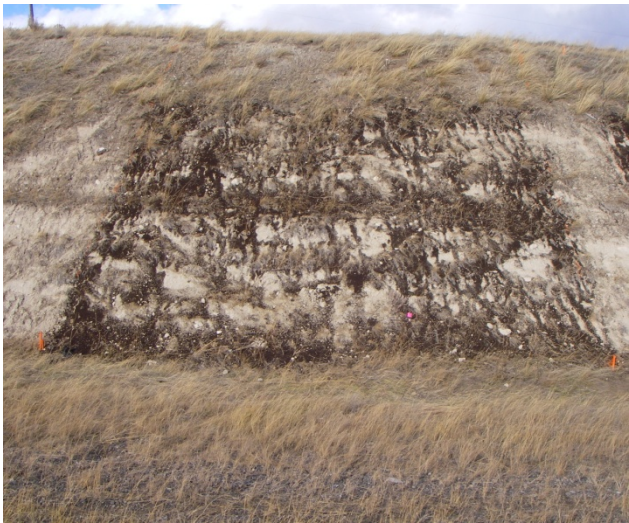
A photograph of a steep, eroded cut slope covered in dry, yellowish-brown grass. The soil surface is exposed and shows signs of erosion.

A photograph showing the same cut slope as in the 'Before' image, but with a large, dark, rectangular area of compost applied to the face of the slope. The compost is dark brown/black and appears to be held in place by some vegetation or mesh.
Plot 8 Before Construction	Plot 8 After Construction

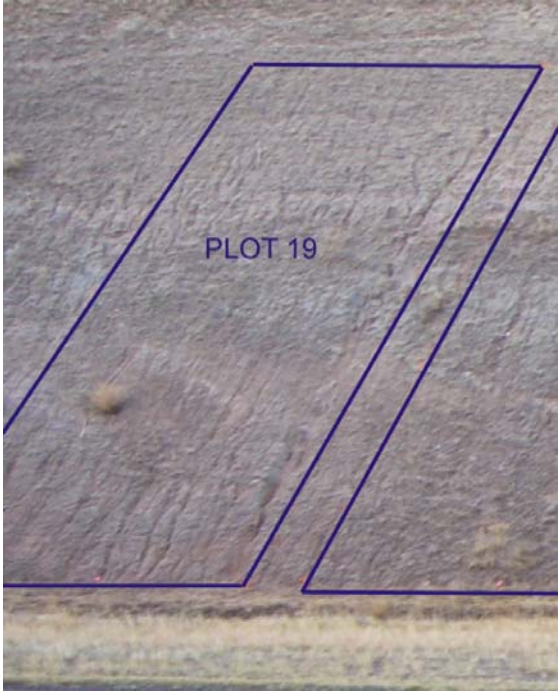
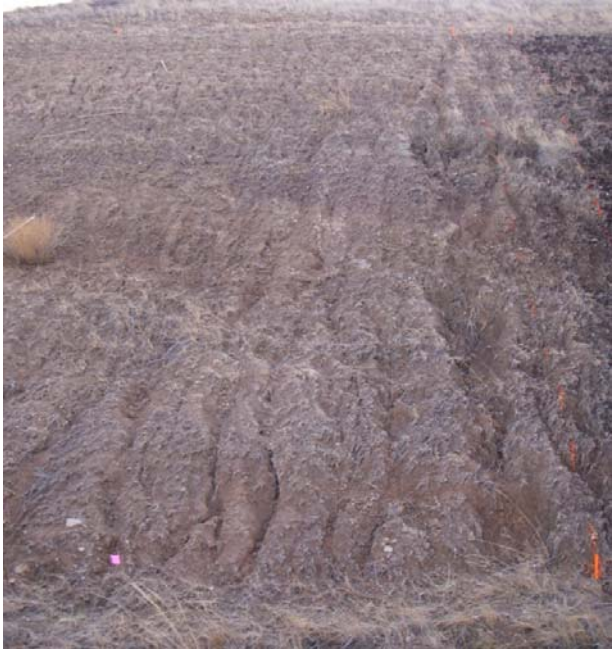
<p>A photograph of a dirt cut slope. A blue parallelogram outline is drawn on the slope, with the text "PLOT 19" centered within it. The slope surface is uneven and shows some erosion patterns.</p>

<p>A photograph of the same dirt cut slope as in the 'Before' image, but now covered with a dense layer of dark brown, fibrous compost material. The texture is much more uniform and organic.</p>
<p>Plot 19 Before Construction</p>	<p>Plot19 After Construction</p>

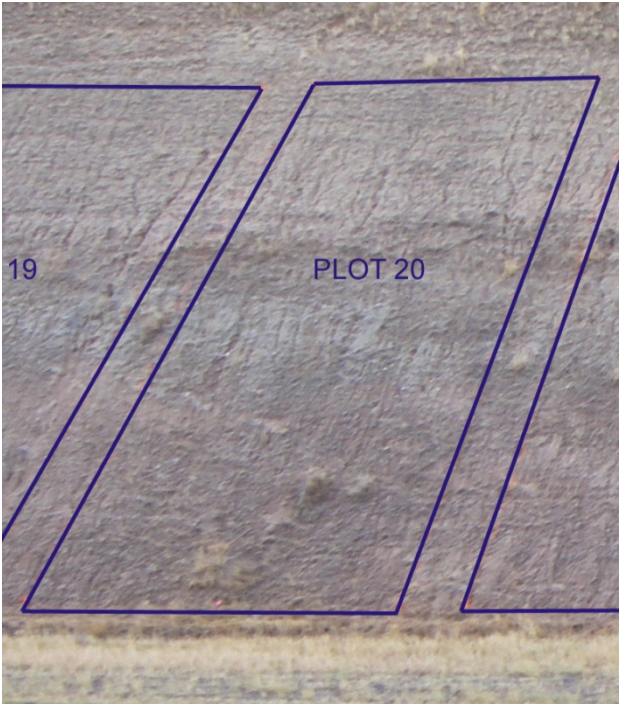
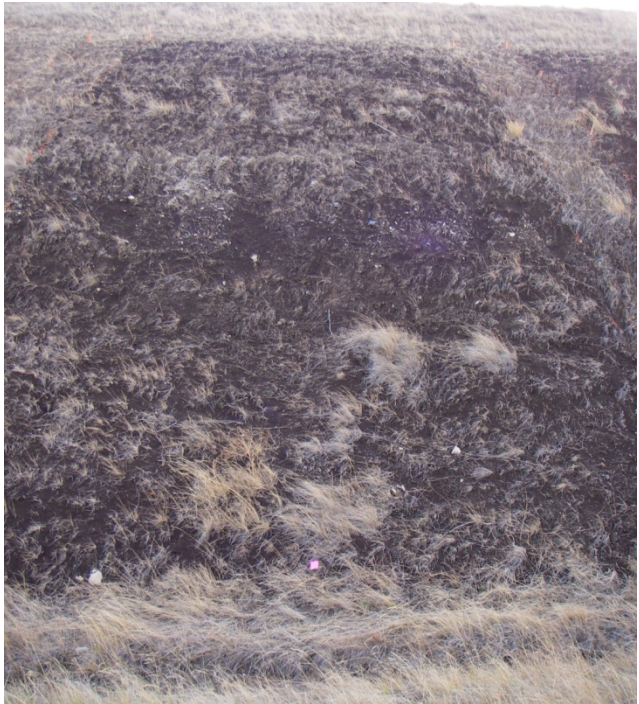
<p>Plot 20 Before Construction</p>	<p>Plot 20 After Construction</p>

<p>A photograph of a dirt cut slope. A blue parallelogram outline is drawn on the slope, with the text "PLOT 20" centered within it. To the left of the plot, the number "19" is visible. The slope surface is uneven and shows some erosion patterns.</p>

<p>A photograph of the same dirt cut slope as in the 'Before' image, but now covered with a dense layer of dark brown, fibrous compost material. The texture is much more uniform and organic.</p>
